**ORDER
ISSUED UNDER THE
WATER POLLUTION CONTROL ACT
WEST VIRGINIA CODE, CHAPTER 22, ARTICLE 11**

TO: Benedum Airport Authority
Attn: Richard Rock
2000 Aviation Way
Bridgeport, WV 26330

DATE: March 14, 2022

ORDER NO.: 10033

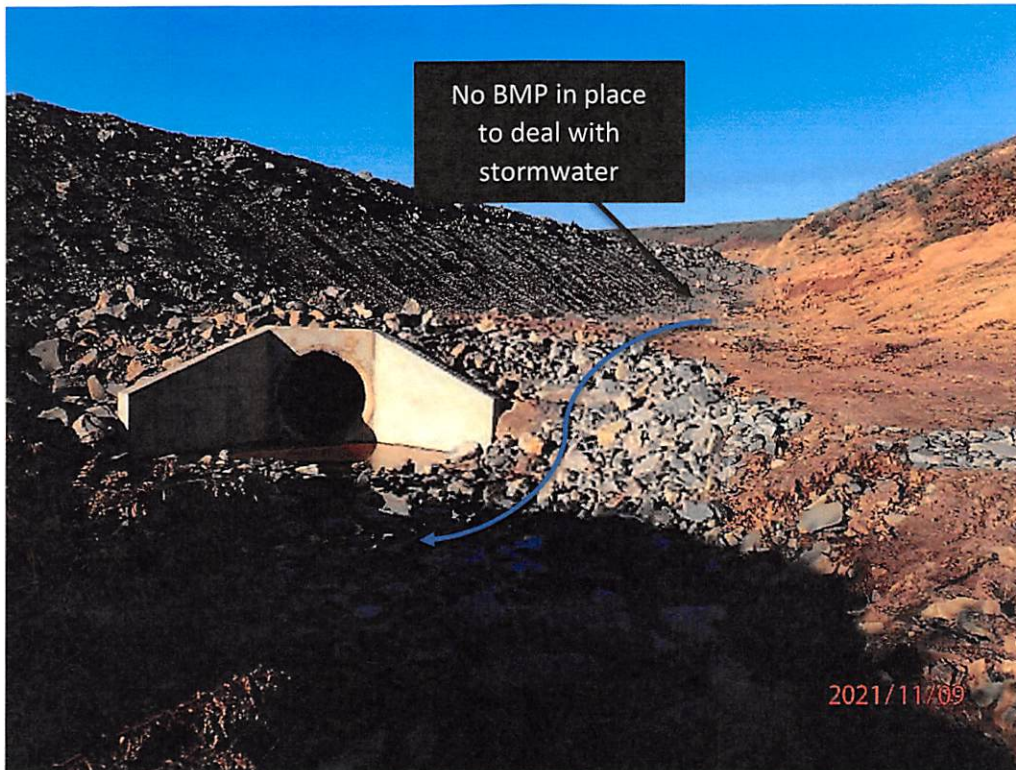
1. Benedum Airport Authority is conducting land disturbance activity in Harrison County, West Virginia. Benedum Airport Authority was issued WV/NPDES Water Pollution Control Permit No. WV0115924, Registration No. WVR110649, on July 7, 2020.
2. On November 9, 2021, West Virginia Department of Environmental Protection (WVDEP) personnel conducted an inspection of the facility. During the inspection, violations of the following sections of West Virginia Legislative Rules and the WV/NPDES permit were observed and documented:
 - a. Section III.C.2.- Benedum Airport Authority failed to modify the Stormwater Pollution Prevention Plan (SWPPP) whenever it proved to be ineffective in achieving the general objectives of controlling pollutants in storm water discharges associated with construction activities. The inlet that drains Pad 1 had no BMP in place for

sediment laden water. There was also a diversion ditch that was without a BMP leading to this inlet.

Photo shows the inlet that drains from pad 1. There was no BMP/treatment in place for the water that entered the culvert.

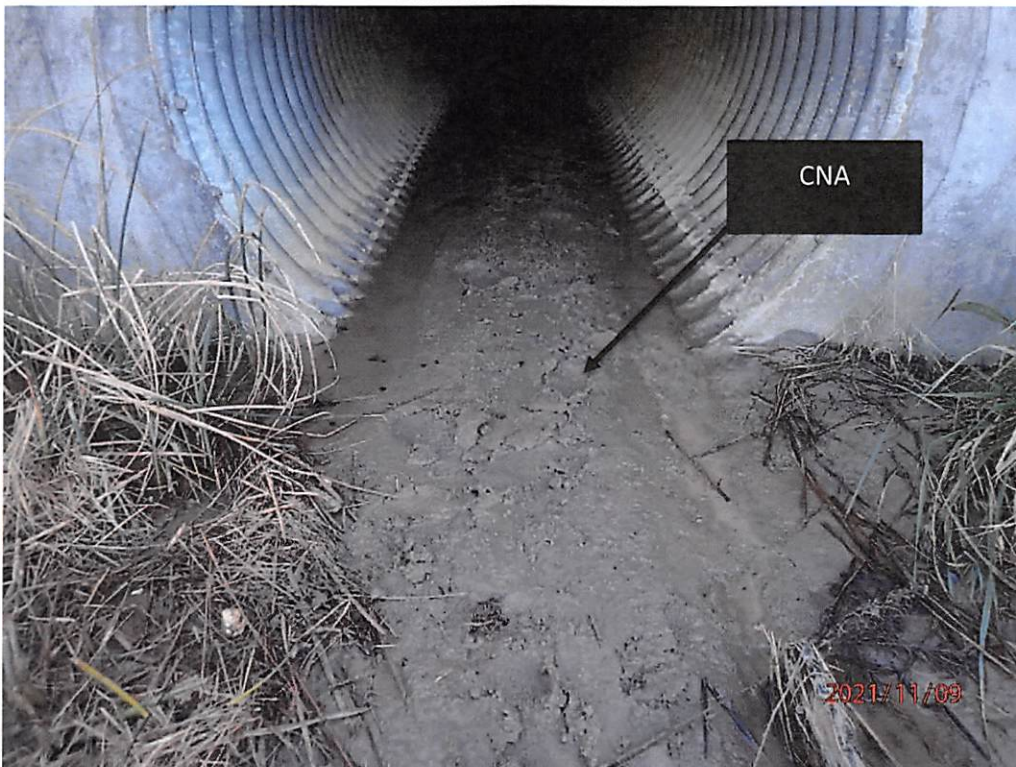
- d. 47CSR2 Section 3.2.b.- Benedum Airport Authority caused conditions not allowable in waters of the State by creating sediment deposits on the bottom of the stream. Due to the lack of BMPs at the inlet for Pad 1, there were sediment deposits at the outlet for the project on Ann Run (39.303583, -80.227815).

Photo shows the outlet to the culvert in the previous photo with conditions not allowable (CNA).

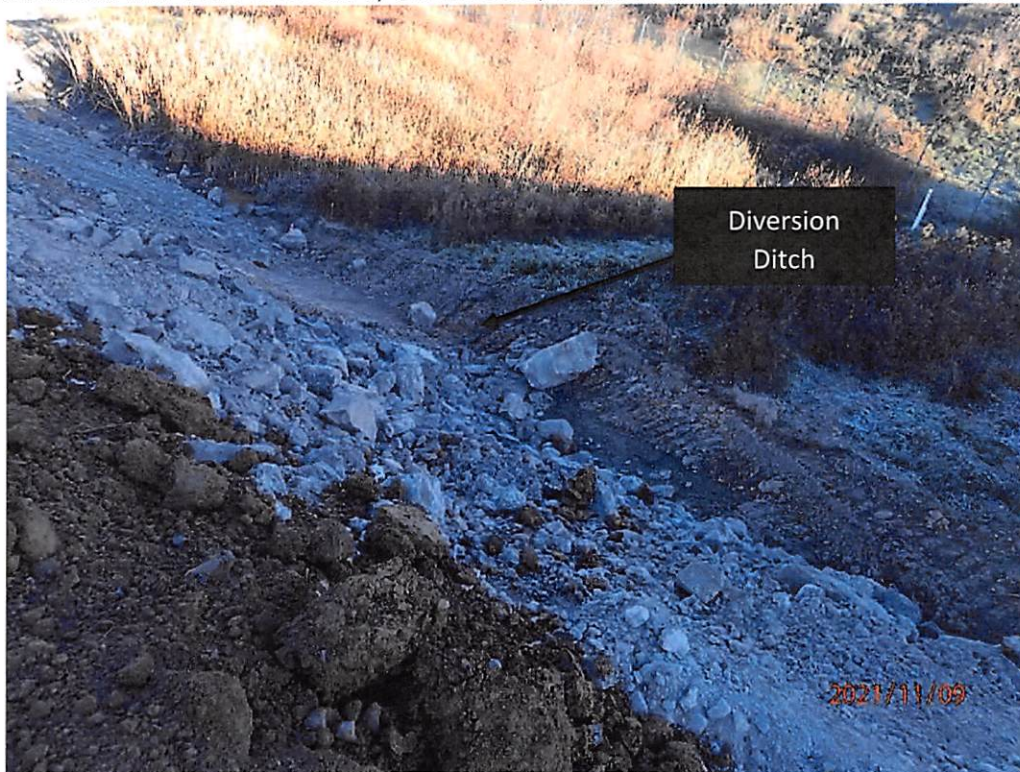
Photo shows a diversion ditch without any BMP/Treatment that leads to the inlet for pad 1 (shown in previous photos).

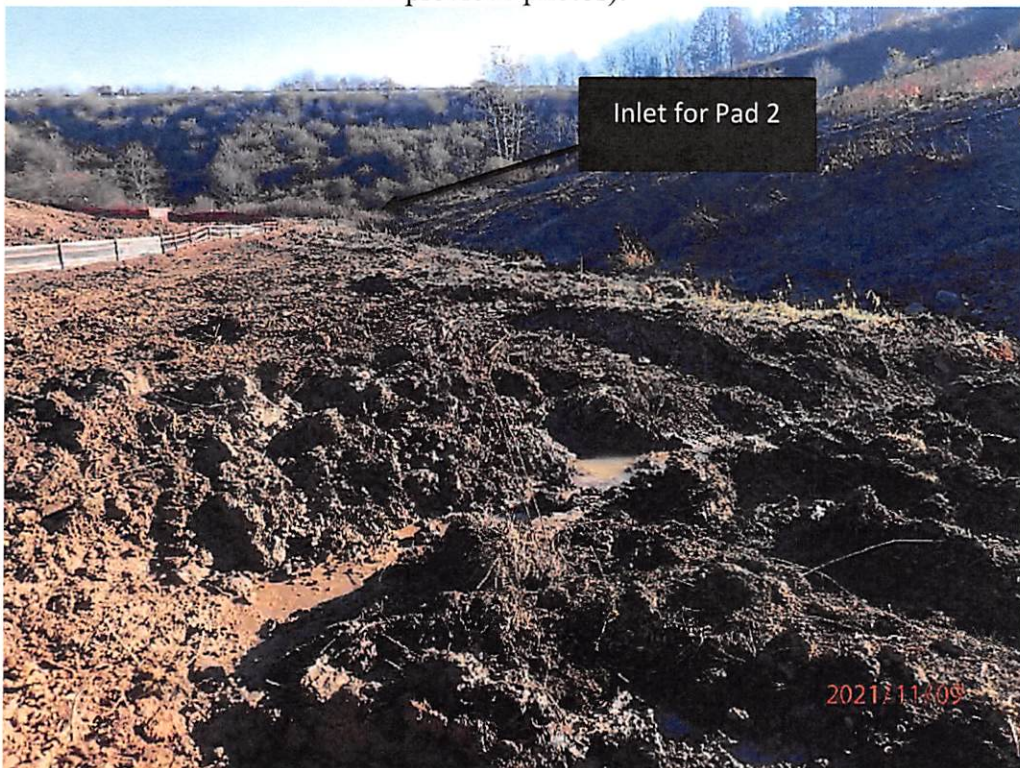
Photo shows drainage leading to the inlet for pad 2. The plans do not call for a BMP, and there is no treatment for the stormwater.

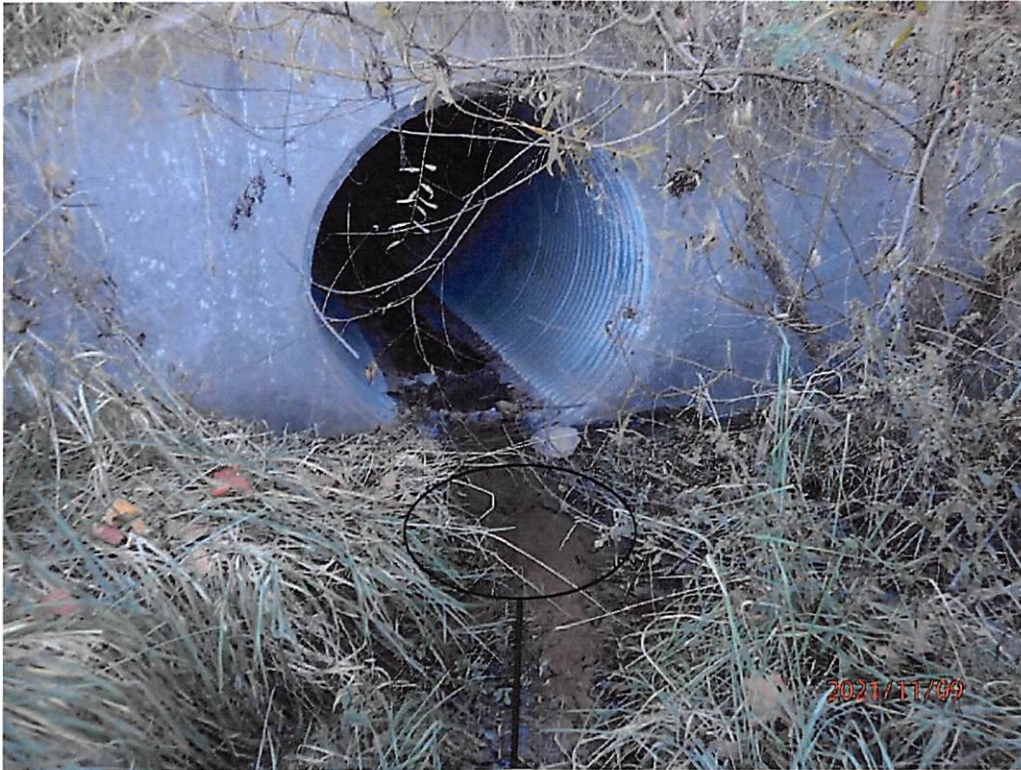
- c. Section I.G.- Benedum Airport Authority failed to prevent sediment-laden water from leaving the site without going through an appropriate device. Sediment-laden water was leaving the site at the inlet for the drainage area for Pad 2.

Photo shows inlet for pad 2. There was evidence of sediment laden water leaving the site.

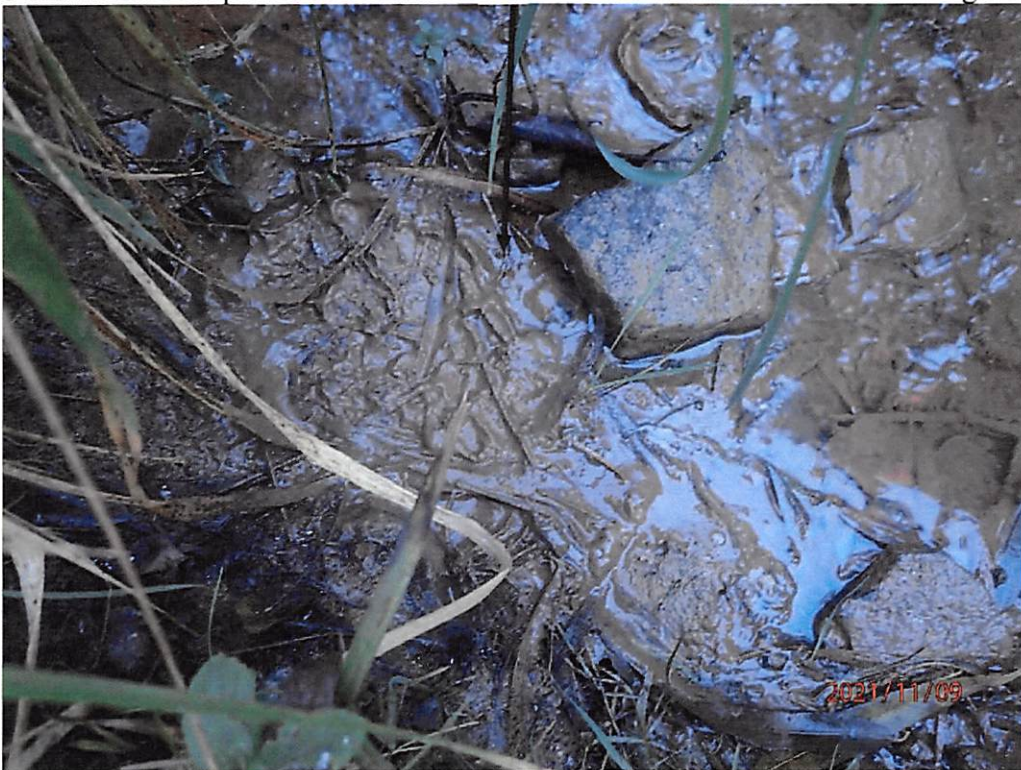
Photo shows sediment deposits leading into the inlet that drains pad 2.

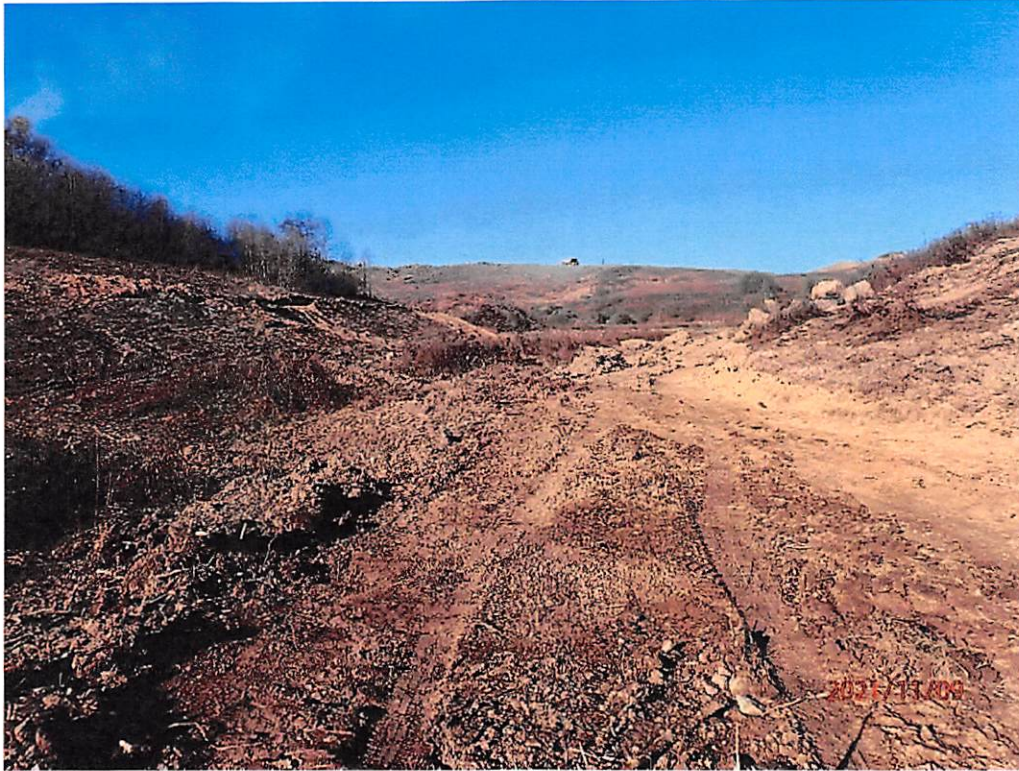
- b. Section I.B.- Benedum Airport Authority failed to comply with the approved SWPPP. Several erosion control devices were not in place as detailed by the SWPPP. According to the SWPPP, in the drainage area for Pad 2, Sediment Traps 1-4 and the associated diversions were supposed to be in place prior to any disturbance. However, none of the traps or diversions were in place, and almost the entire area for Pad 2 had been cleared.

Photo shows drainage area for pad 2. There were no BMPs in place to deal with the water coming out of this drainage area. The SWPPP called for several sediment traps.

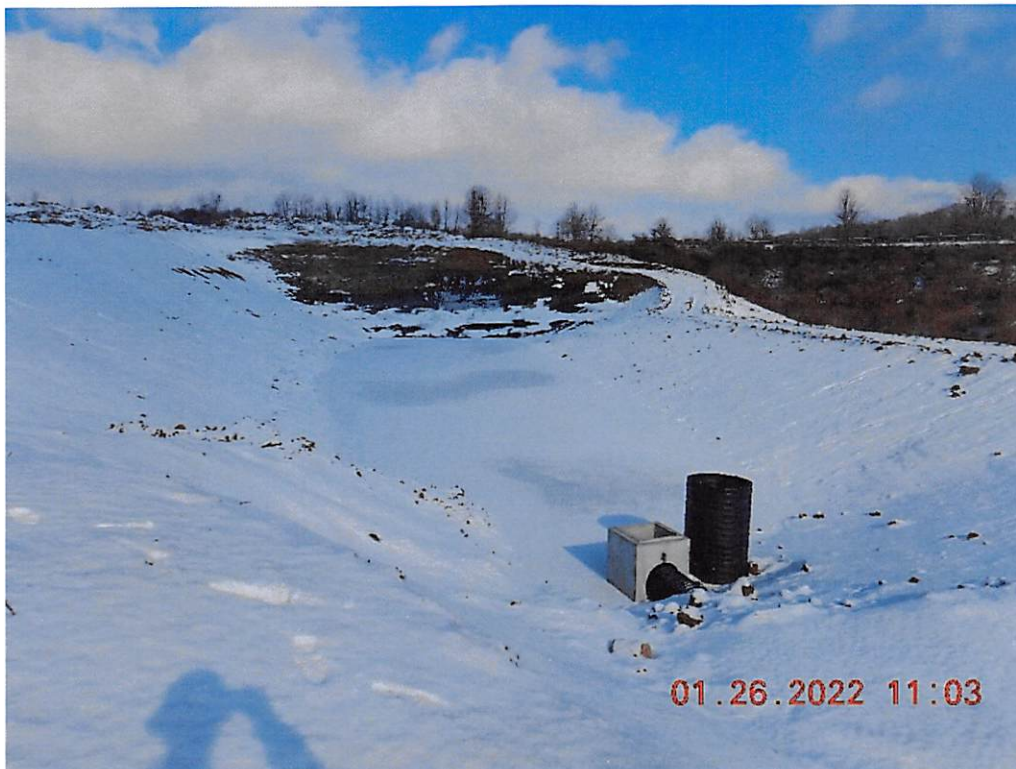
- b. Section II.H.3.b.11.- Benedum Airport Authority failed to properly operate the sediment basin. Sediment Basin 2 was not holding water due to a leaking riser. Water was actively discharging underneath the pipe and out of the basin.

Photo shows Sediment Basin 2 which was not holding water due to a leaking riser.

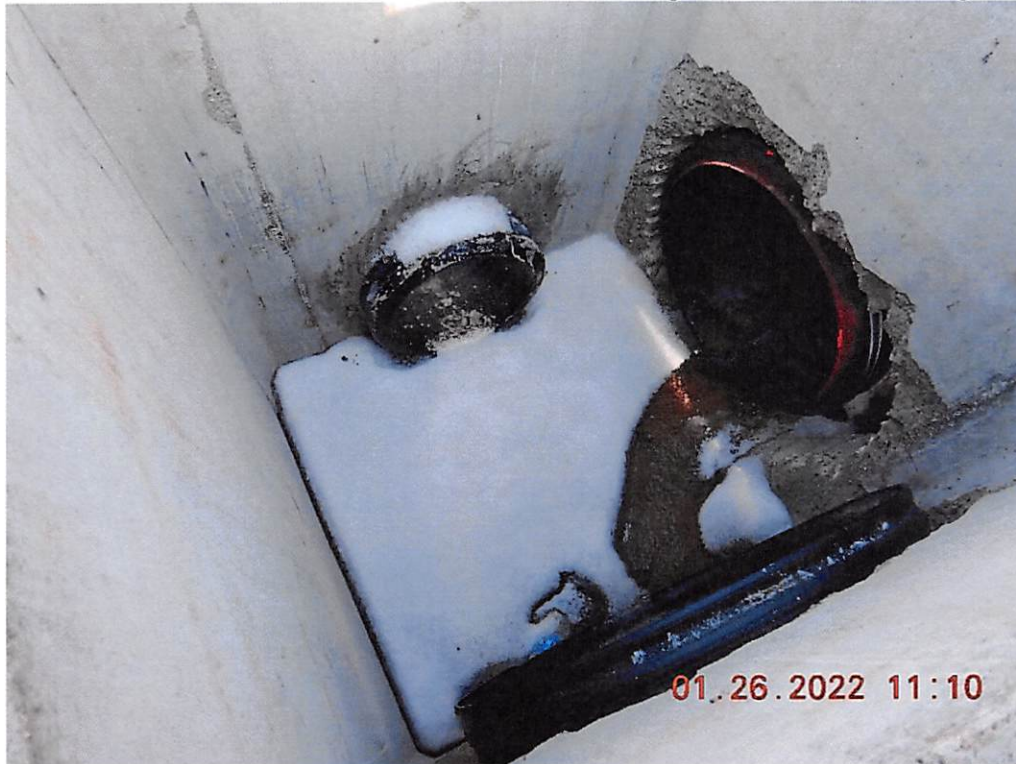
Photo shows the leaking riser for Sediment Basin 2. The water was flowing underneath the pipes and out of the basin.

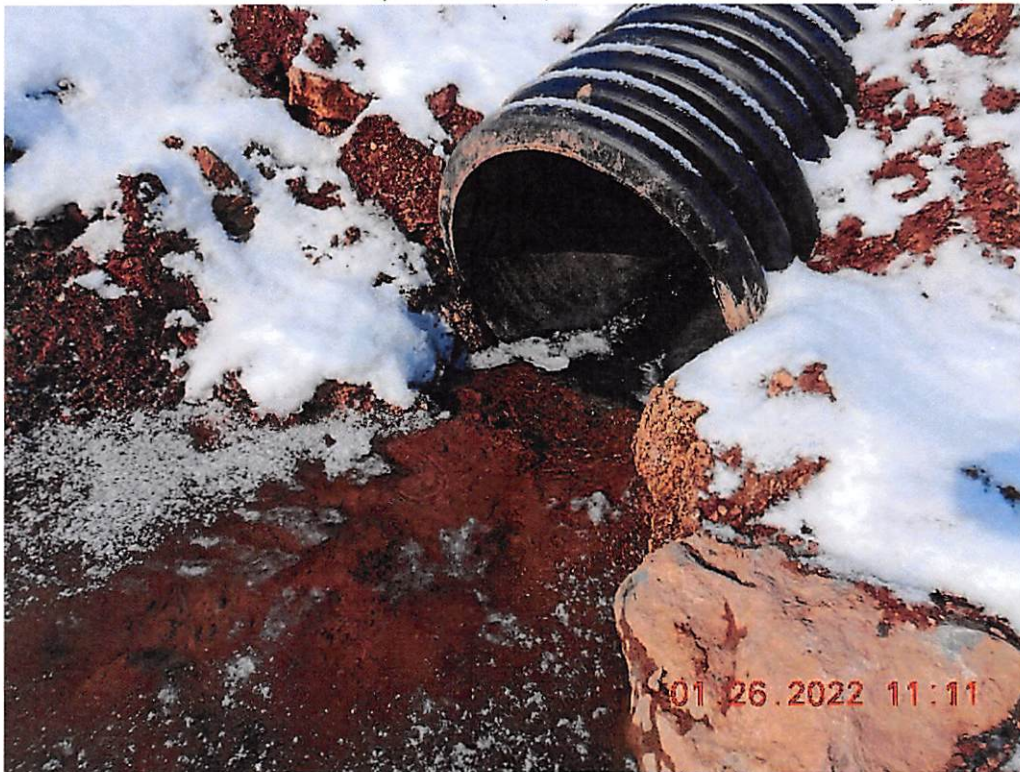
Photo shows outfall from Sediment Basin 2. The water is flowing underneath the pipe.

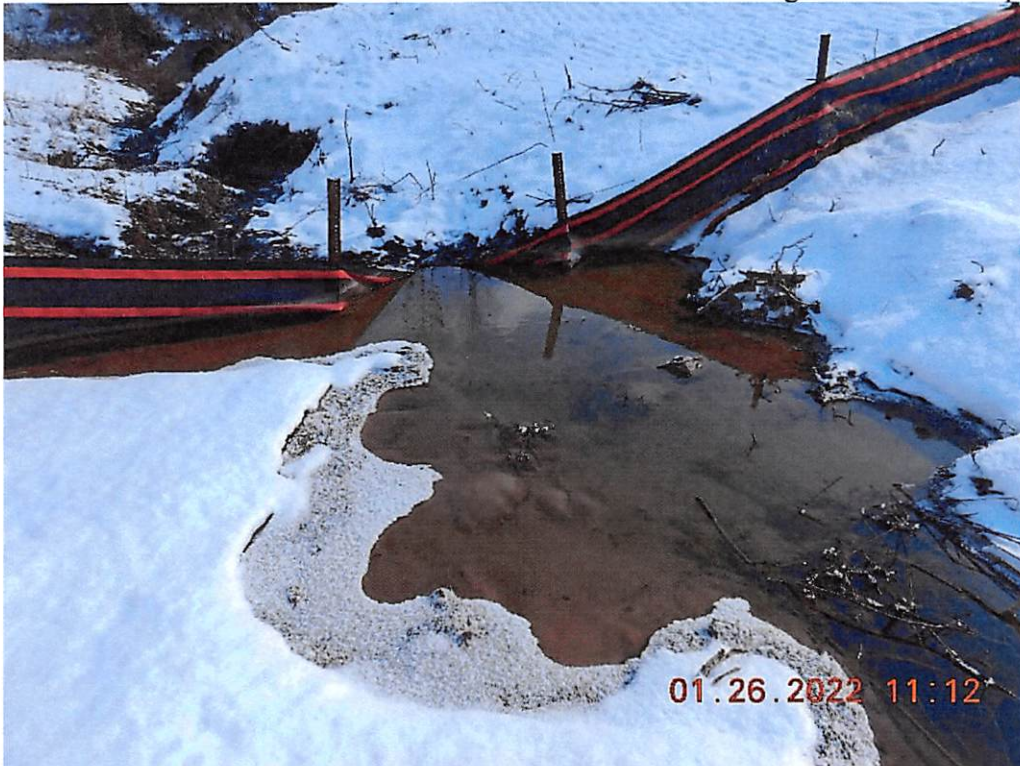
Photo shows silt fence being used as a BMP for concentrated flow near the outlet for Pad 2.

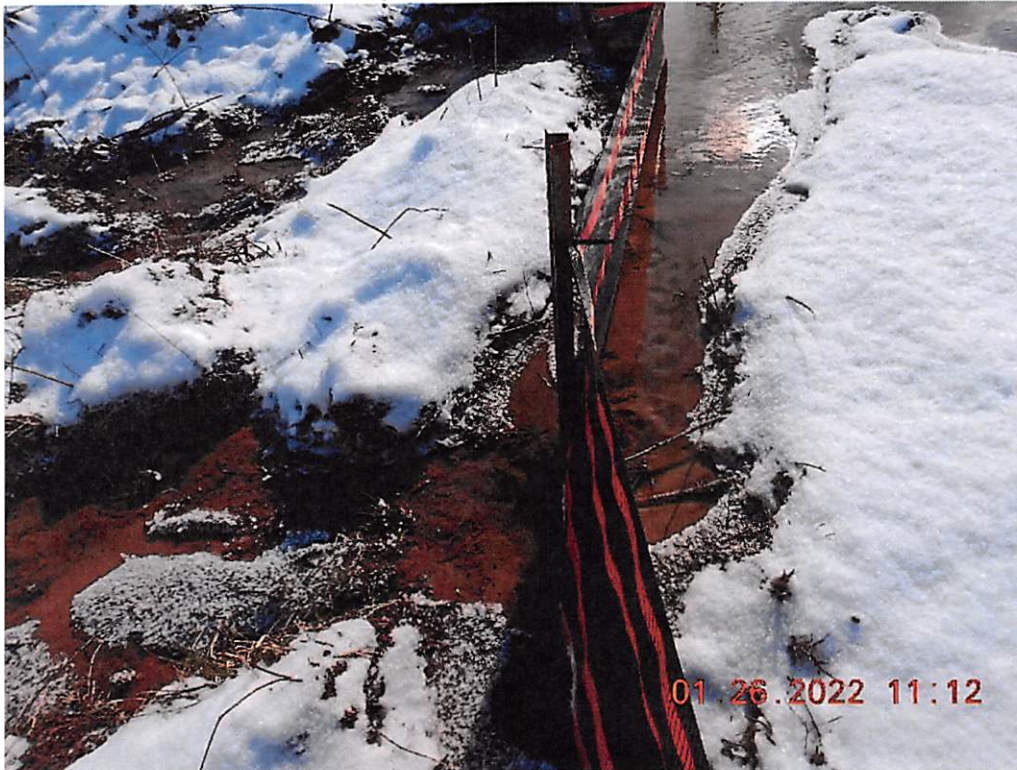
- a. Appendix B.I.1. – Benedum Airport Authority failed to properly operate and maintain all activities and installed BMPs. There were several areas on the project, especially around Pad 2, where the silt fence was undercut, allowing sediment laden water to discharge off-site.

Photo shows the silt fence being undercut and bypassed by the concentrated flow.

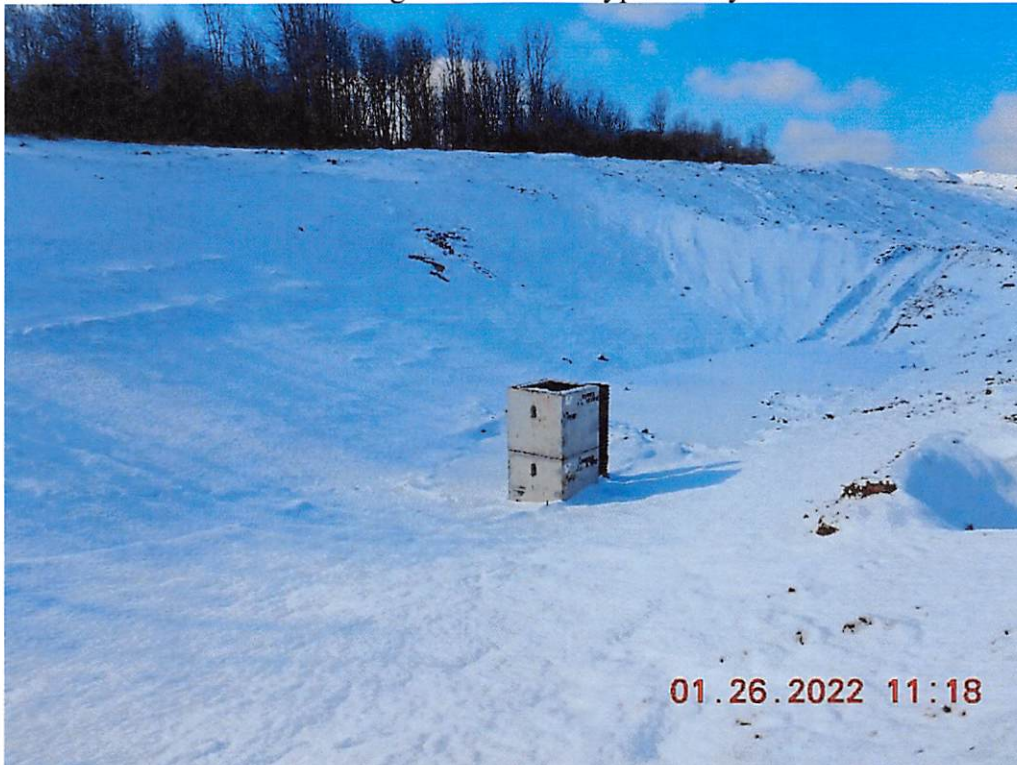
- c. Section I.B.- Benedum Airport Authority failed to comply with the approved SWPPP. Several erosion control devices were not in place as detailed by the SWPPP. There was no significant water being diverted into either Sediment Basin 2 or 3. Collection Ditch 34 (Sediment Basin 2) and Collection Ditch 14 (Sediment Basin 3), which were supposed to be diverting the water into the basins, were not installed. There was a mixture of phase 1 and phase 2 controls in place.

Photo shows Sediment Basin 3 with no significant drainage area or water being diverted into it.

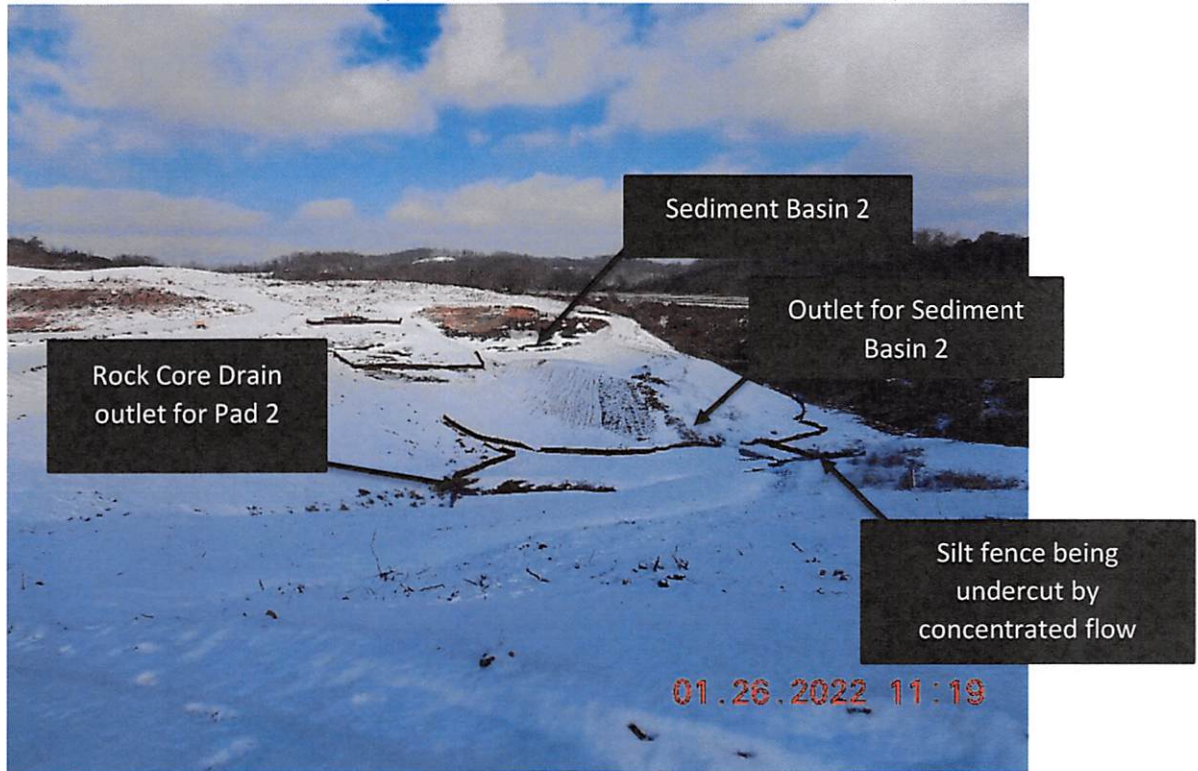
Photo shows overall drainage for Pad 2.

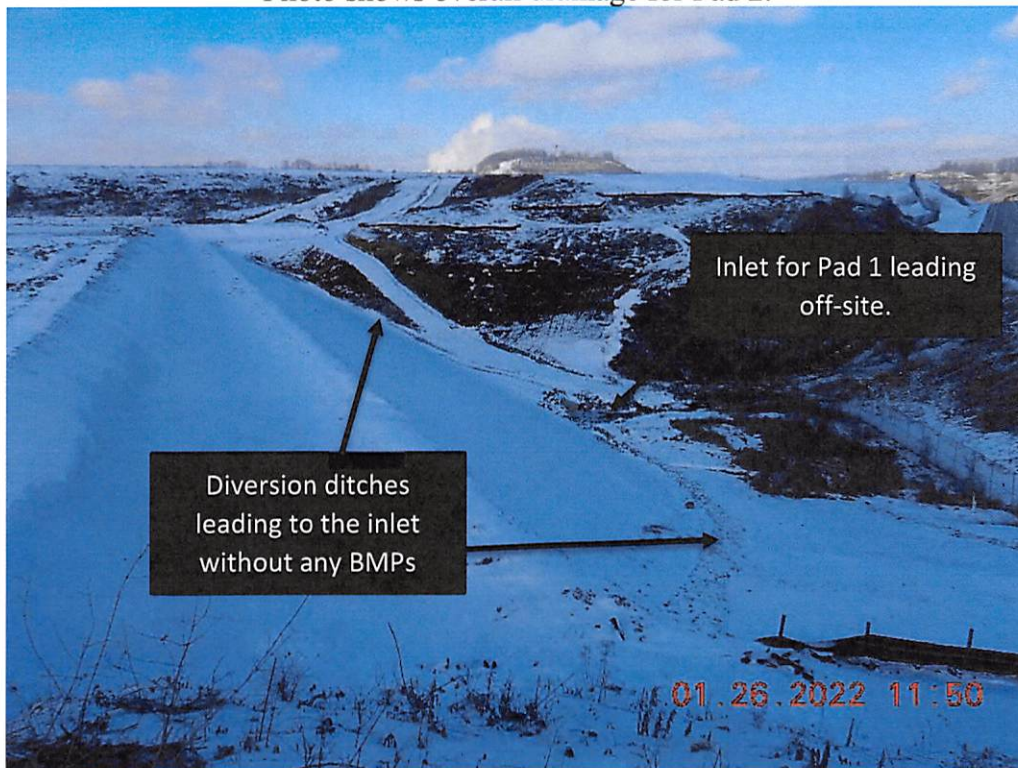
- d. Section III.C.2.- Benedum Airport Authority failed to modify the SWPPP whenever it proved to be ineffective in achieving the general objectives of controlling pollutants in storm water discharges associated with construction activities. There was no BMP in place for the stormwater that drains to the inlet at Pad 1. The SWPPP did not indicate the need for any BMPs in this area, and Benedum Airport Authority failed to modify the plan after becoming aware that it was ineffective.

Photo shows overall drainage for pad 1. All the water is directed down to an inlet without any BMPs in place.

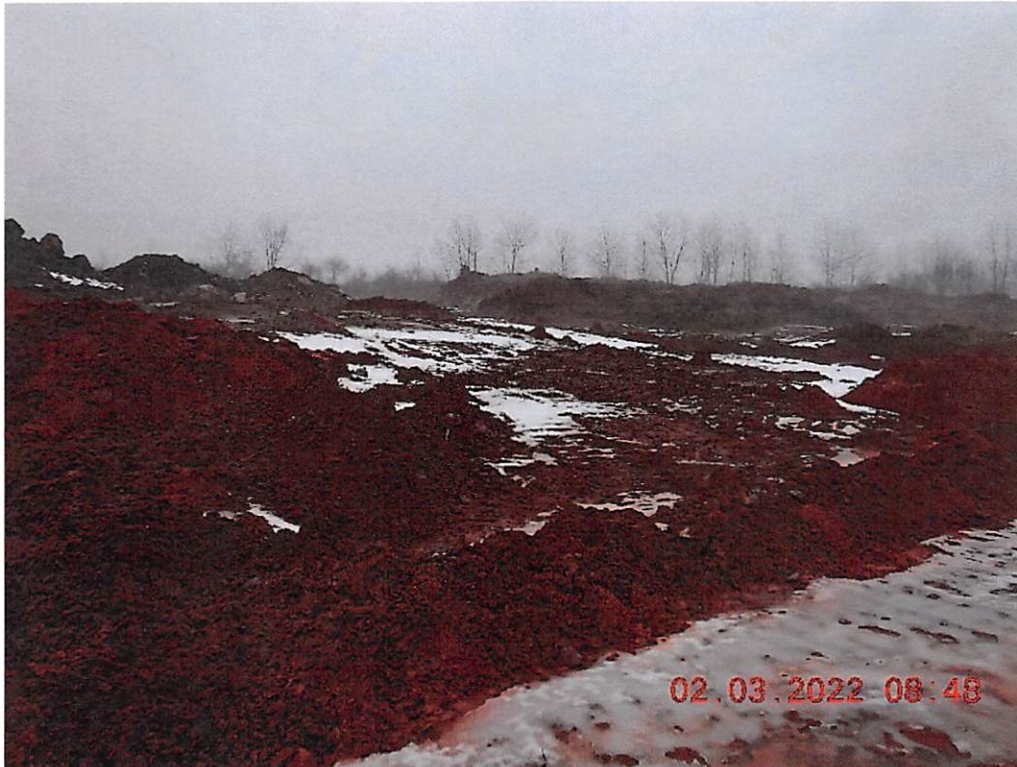
Photo shows bare ground with no temporary stabilization. On-site representatives stated the project had not been worked for three weeks, because of the cold weather. This was consistent over the entire project.

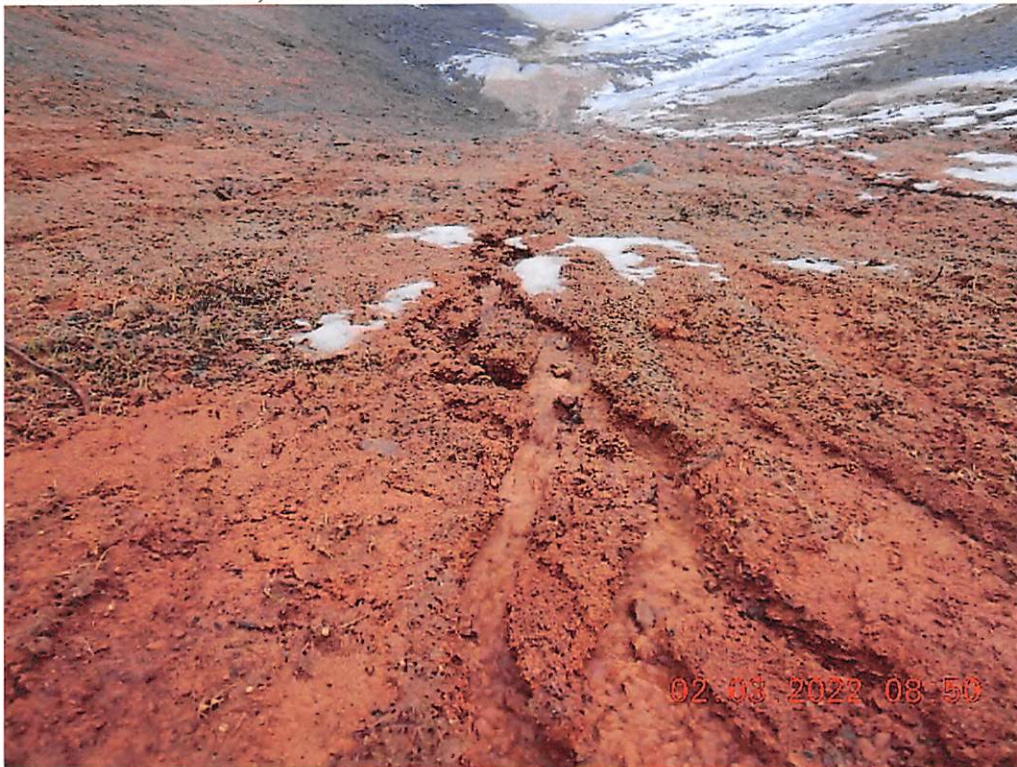
- f. Section II.H.3.b.13.- Benedum Airport Authority failed to provide inlet and outlet protection for sediment control structures. There were also no dump rock gutters installed to Sediment Basin 2, causing fill slope erosion and an unstable inlet for Sediment Basin 2 at a volunteer inlet to the basin.

Photo shows an unstabilized inlet to Sediment Basin 2. According to the approved SWPPP, there should be a dump rock gutter installed to protect the fill slope and stabilize the inlet.

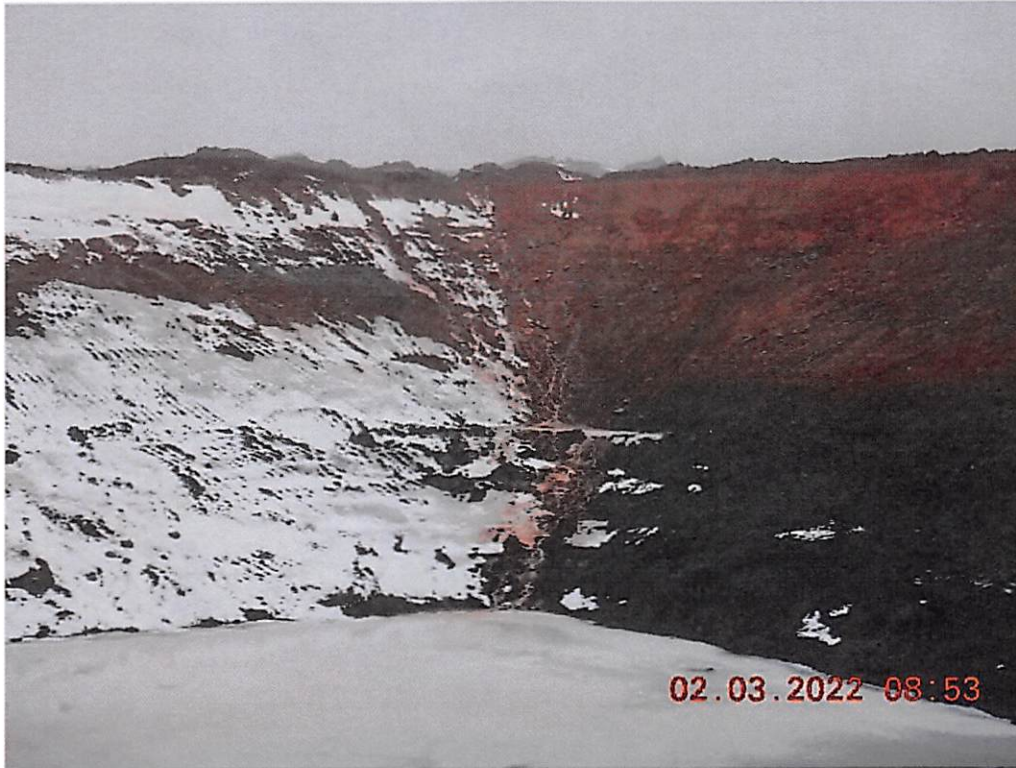
Photo shows another angle of the unstabilized inlet for Sediment Basin 2.

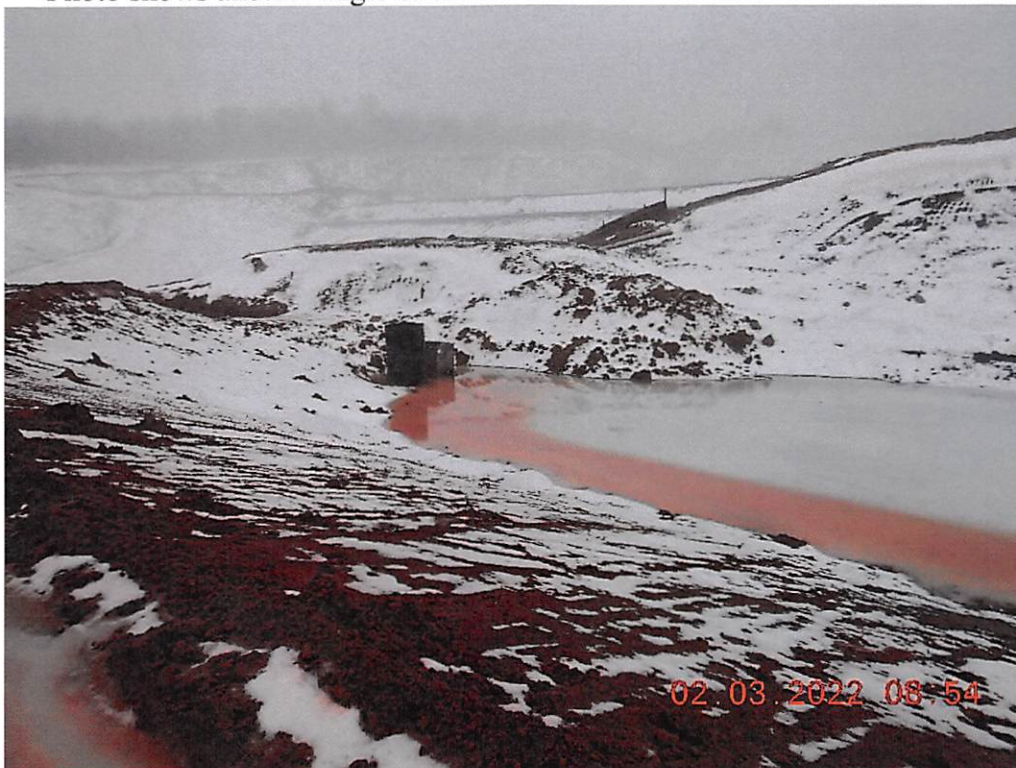
Photo shows sediment laden water from the unstabilized inlet (Sediment Basin 2) flowing toward the riser.

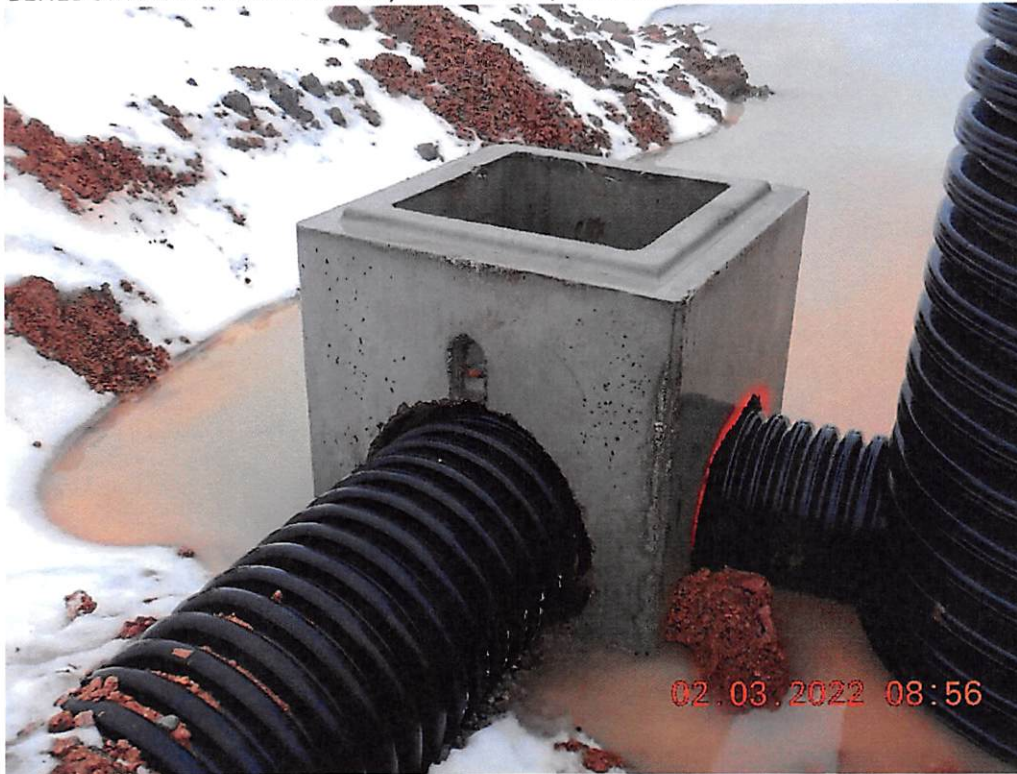
- b. Section II.H.3.b.11.- Benedum Airport Authority failed to properly operate a sediment basin. Sediment Basin 2 was not holding water due to a leaking riser. Water was actively discharging underneath the pipe and out of the basin.

Photo shows the leaking riser for Sediment Basin 2. The water is running underneath the pipe to the outlet for the Basin.

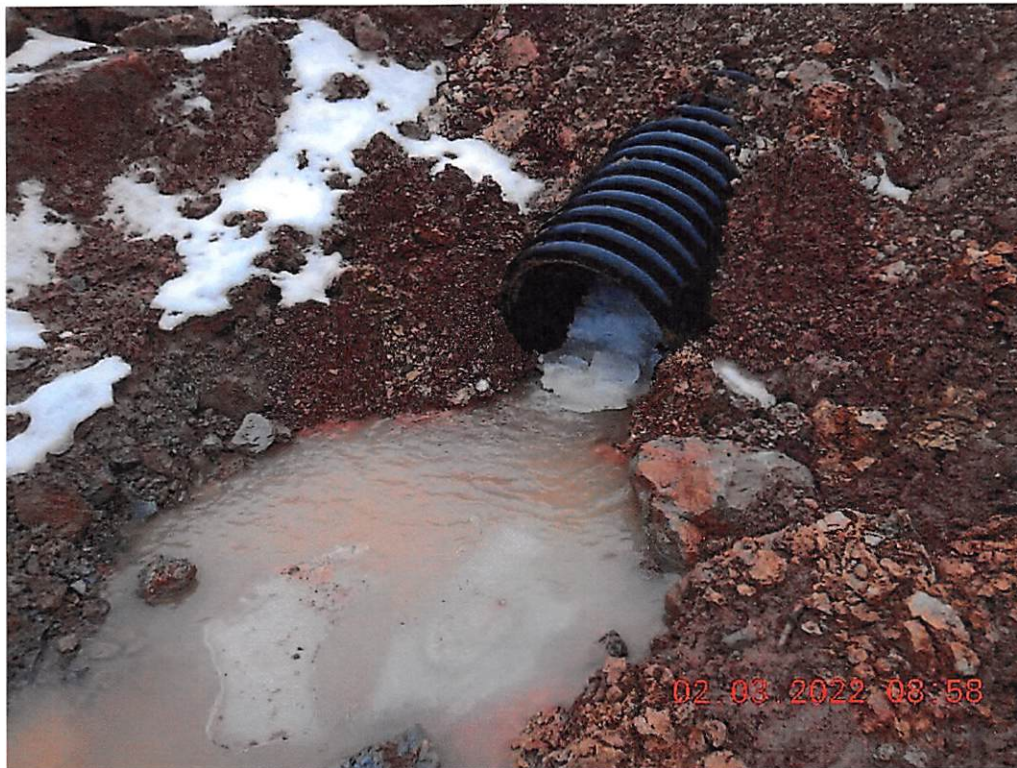
Photo shows the outlet from Sediment Basin 2.

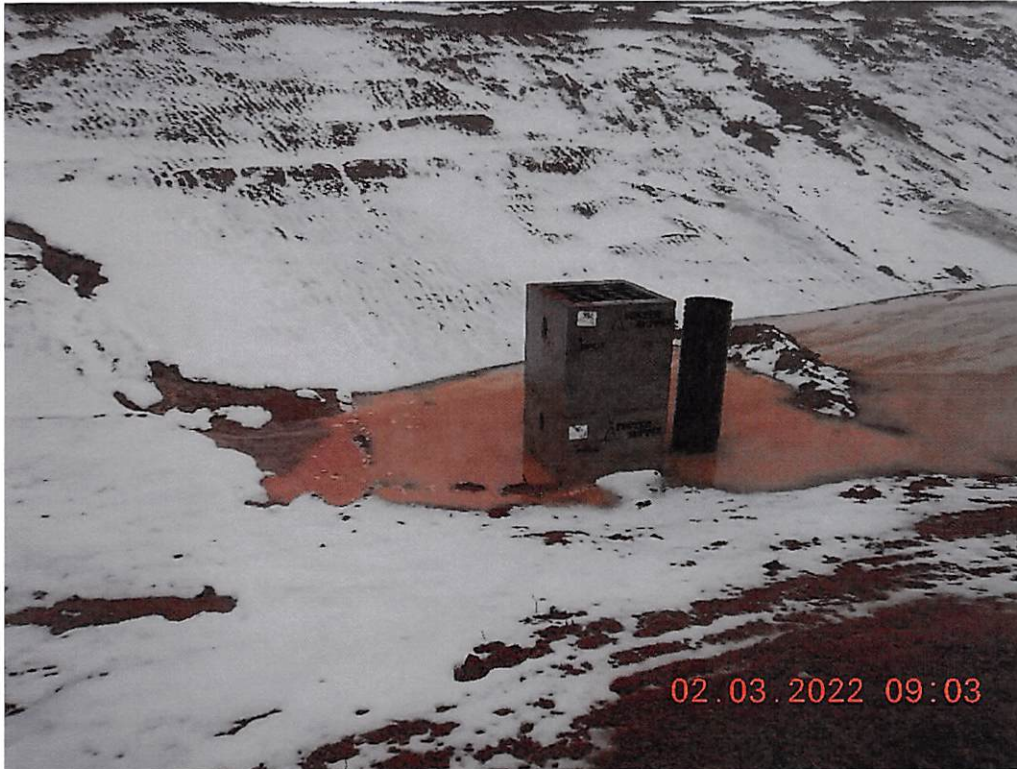
- c. Section I.B.- Benedum Airport Authority failed to comply with the approved SWPPP. Several erosion control devices were not in place as detailed by the SWPPP. There was no significant water being diverted into either Sediment Basin 2 or 3. Collection Ditch 34 (Sediment Basin 2) and Collection Ditch 14 (Sediment Basin 3), which were supposed to be diverting the water into the basins, were not installed. There was a mixture of phase 1 and phase 2 controls in place.

Photo shows Sediment Basin 3. Collection ditch 4 was not installed, so no significant water was being diverted to the basin.

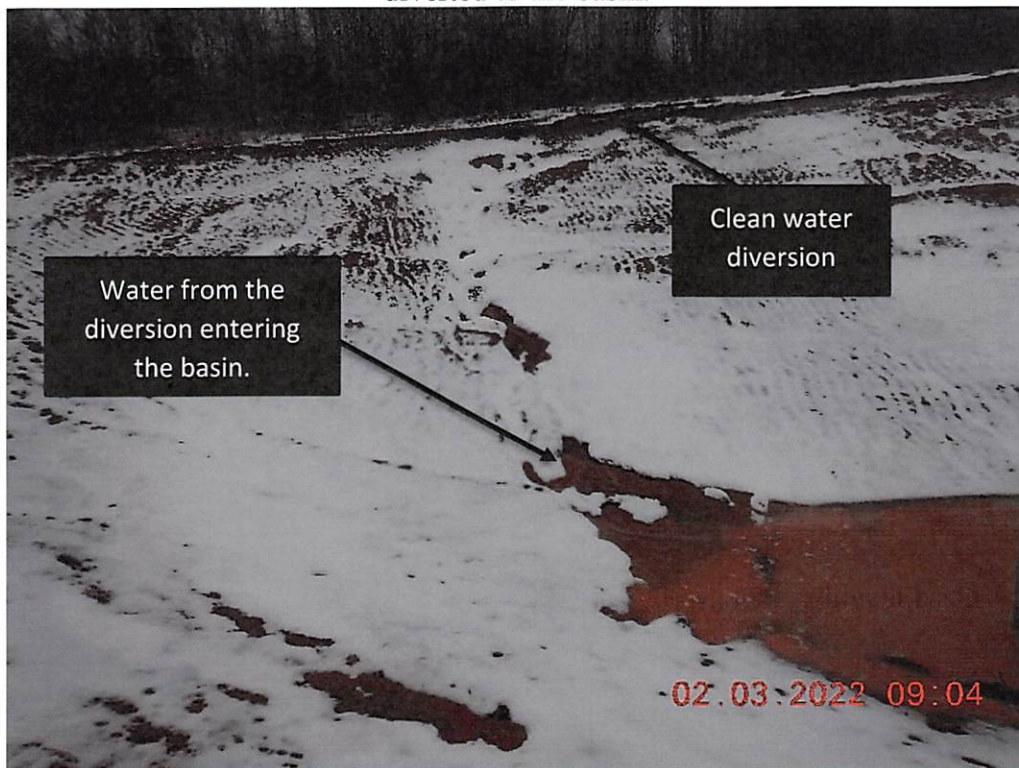
Photo shows the water from the clean water diversion running down into sediment basin 3. This was the only source of water for the basin.

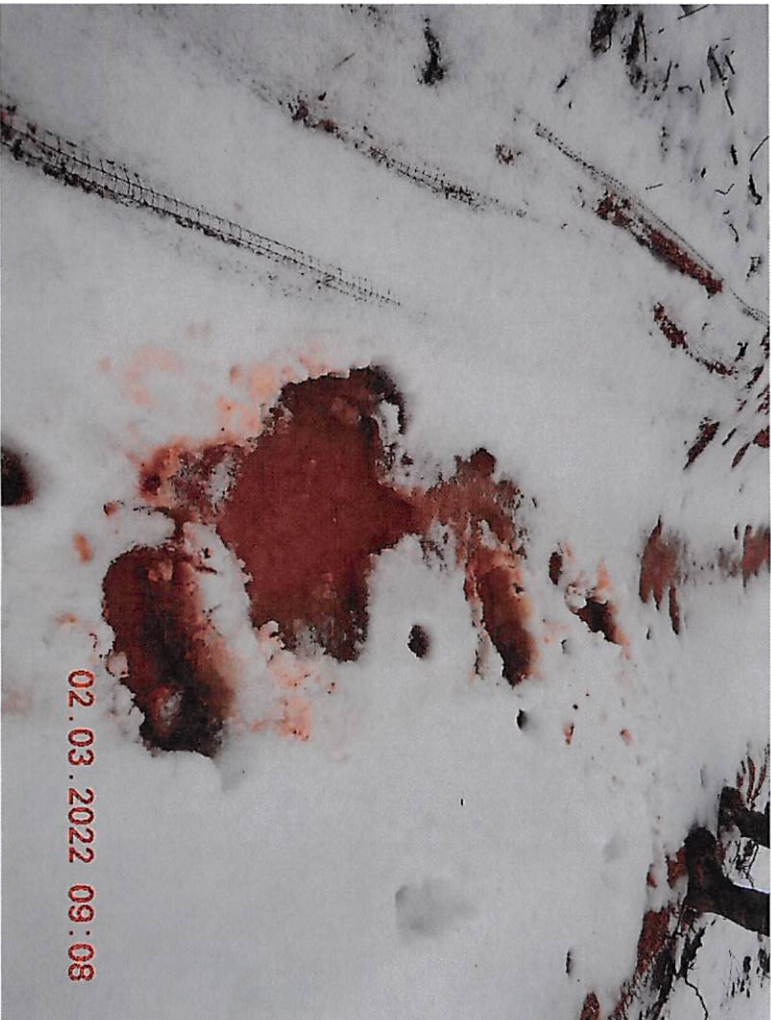
- e. Section II.H.3.b.9. - Benedum Airport Authority failed to stabilize clean water diversions prior to becoming functional. The clean water diversion around Pad 2 was not properly stabilized, causing sediment laden water to bypass all the controls and discharge off-site.

Photo shows sediment laden water in the clean water diversion just above sediment basin 3. The clean water diversion was not properly stabilized.

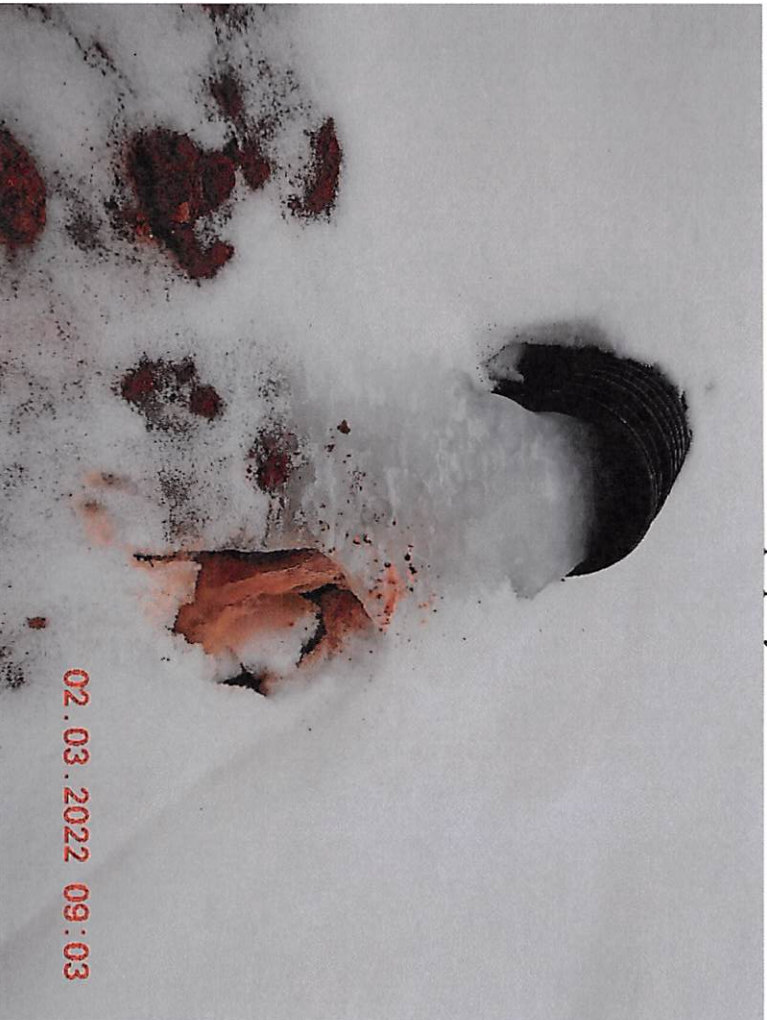
Photo shows sediment laden water leaving Sediment Basin 3.

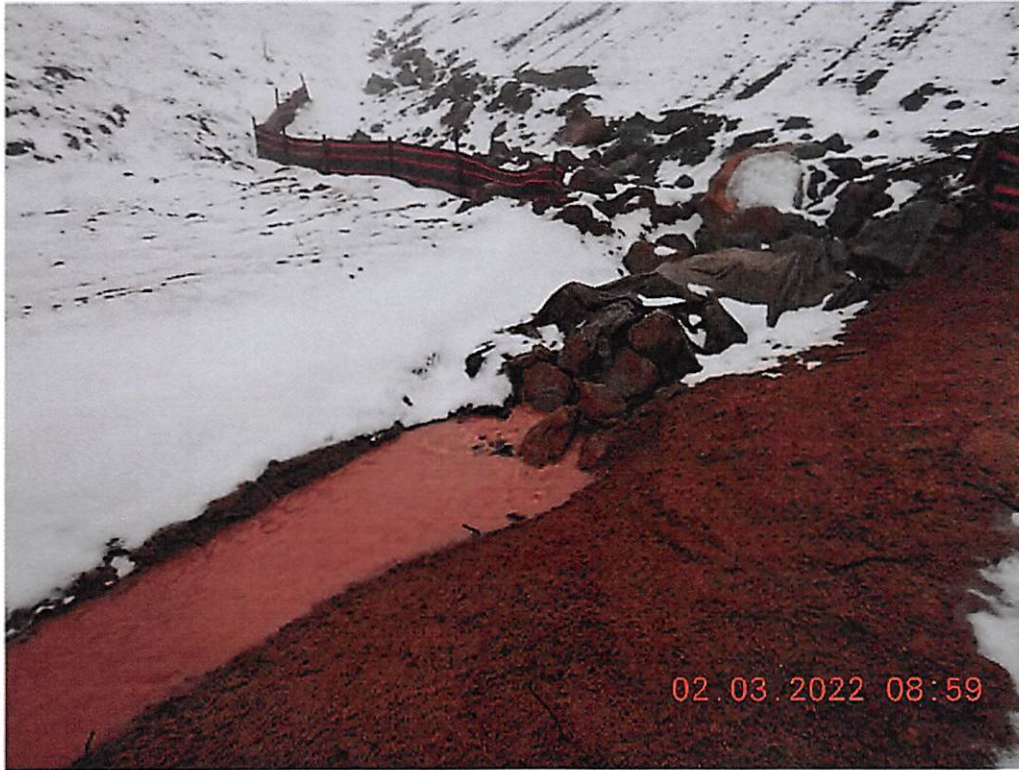
Photo shows the outlet for the rock core drain for Pad 2. The sediment laden water overtops a layer of silt fence before discharging off-site.
